Compendium of WASH in Schools Facilities in Emergencies

DRAFT
UNICEF
2012

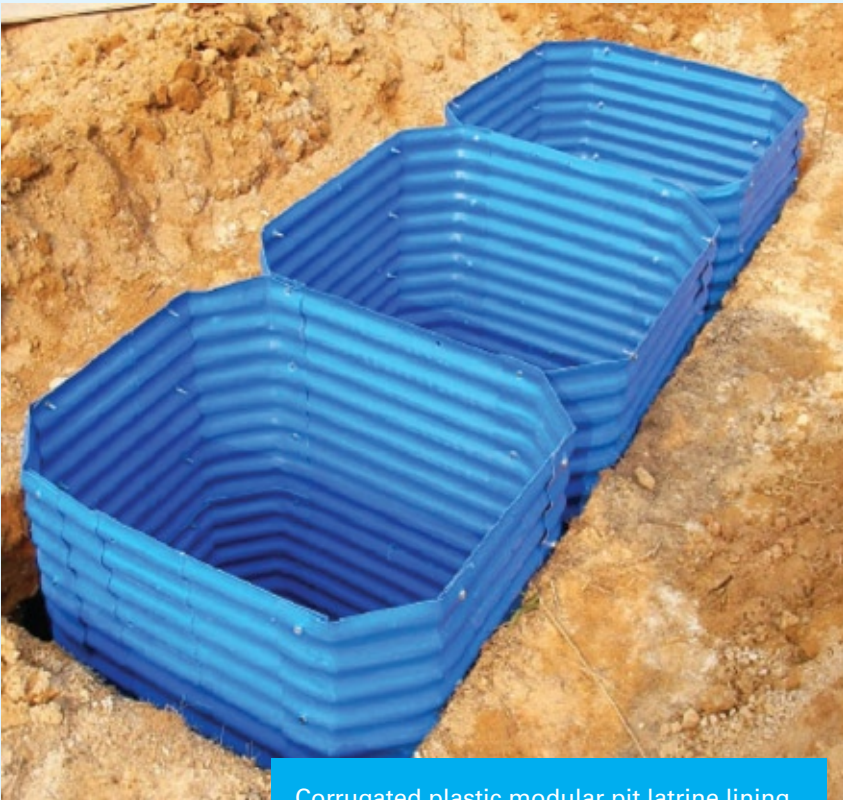
Corrugated plastic modular pit latrine lining (Evenproducts, United Kingdom)

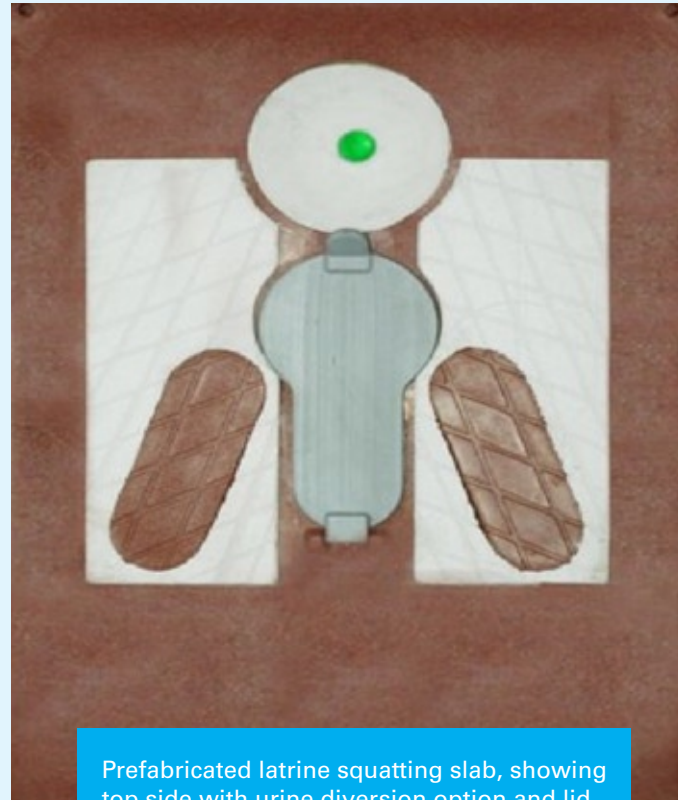
Prefabricated latrine squatting slab, showing top side with urine diversion option and lid for covering squat hole (Nag Magic, India)

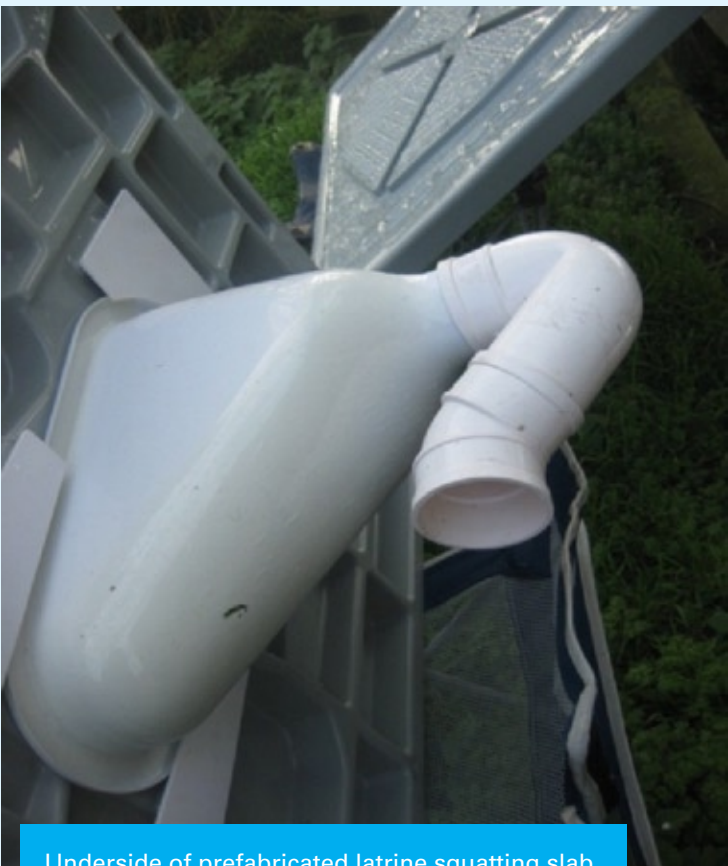
Underside of prefabricated latrine squatting slab, showing u-bend trap (AirCell Structures, UK)

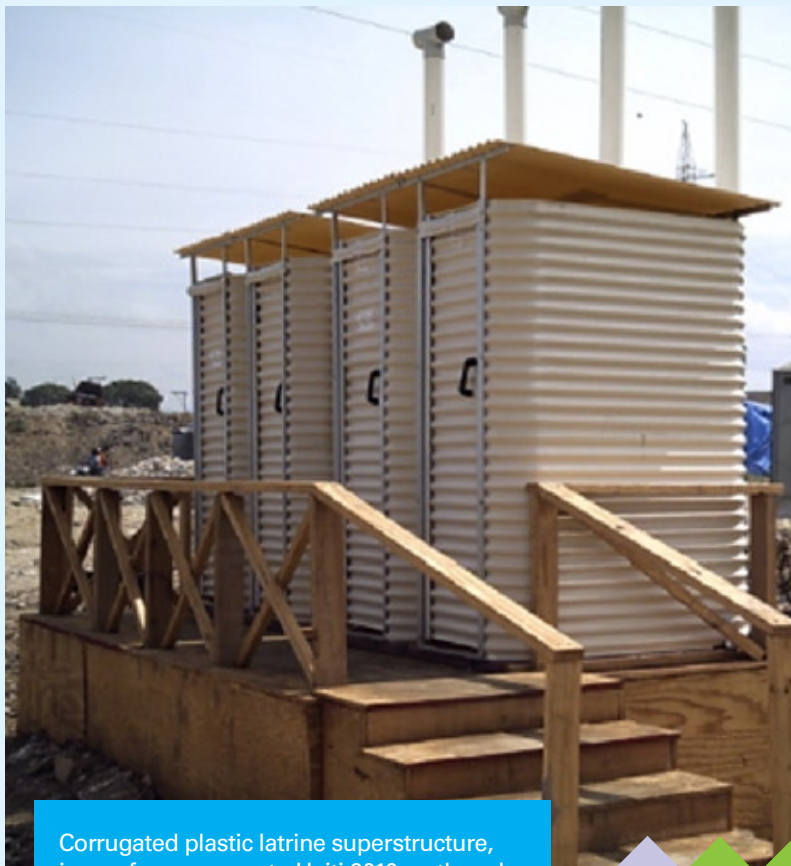
Corrugated plastic latrine superstructure, in use for response to Haiti 2010 earthquake (Evenproducts, United Kingdom)

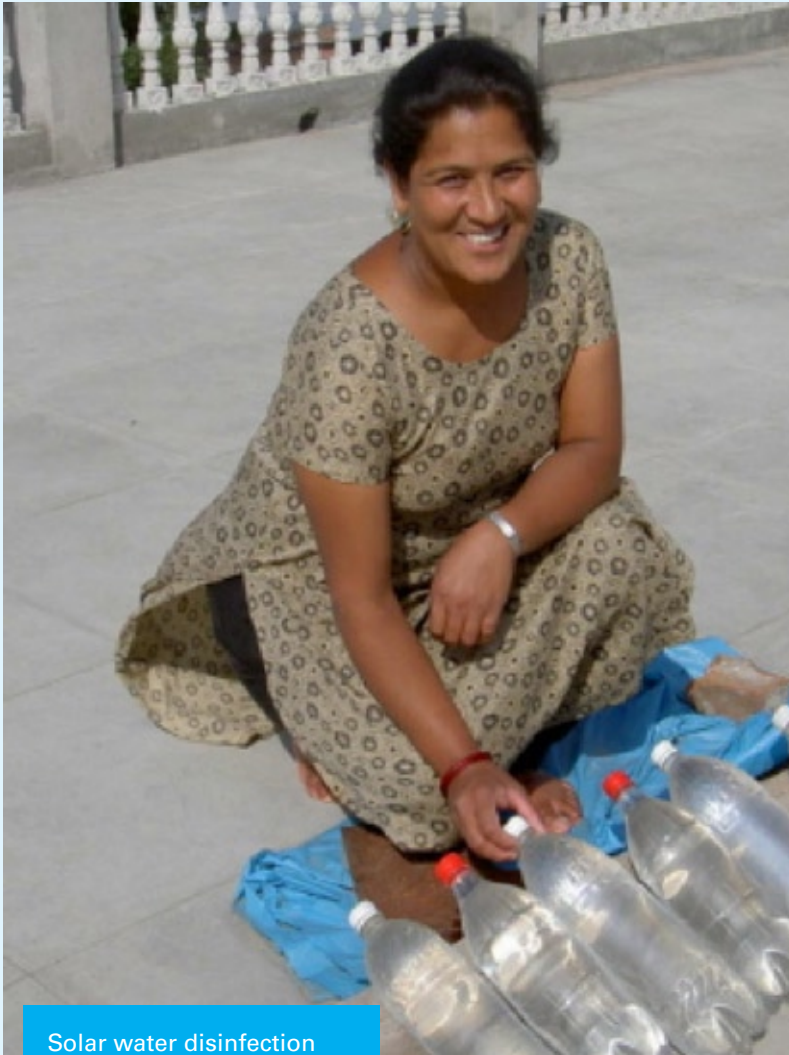
Solar water disinfection using recycled bottles

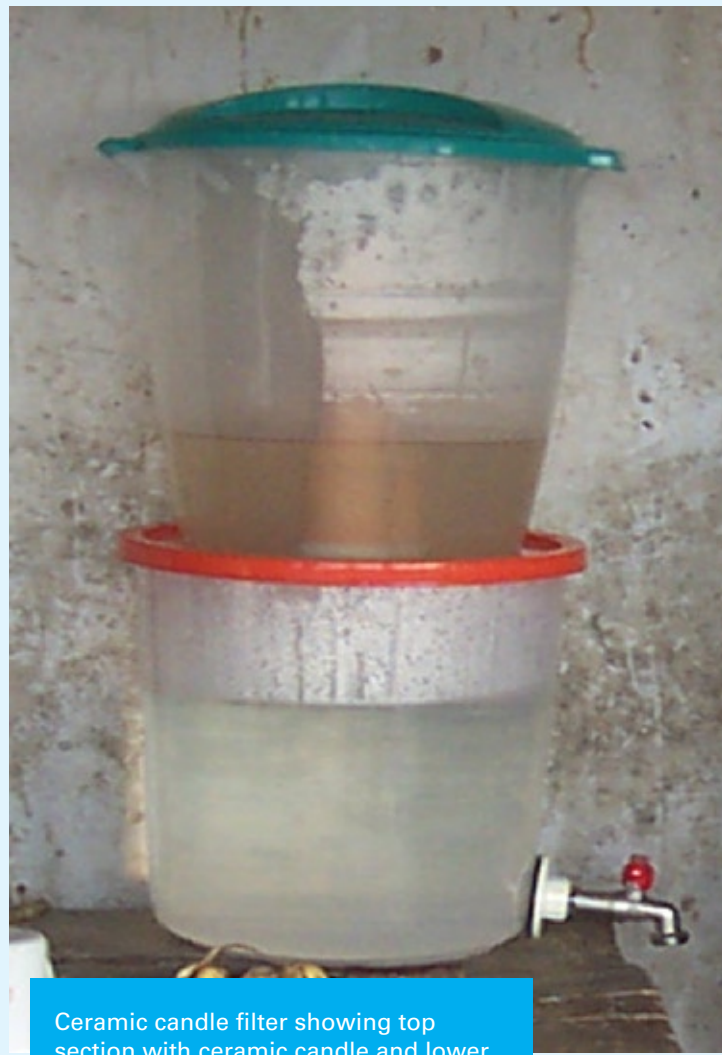
Ceramic candle filter showing top section with ceramic candle and lower section with storage and outlet tap

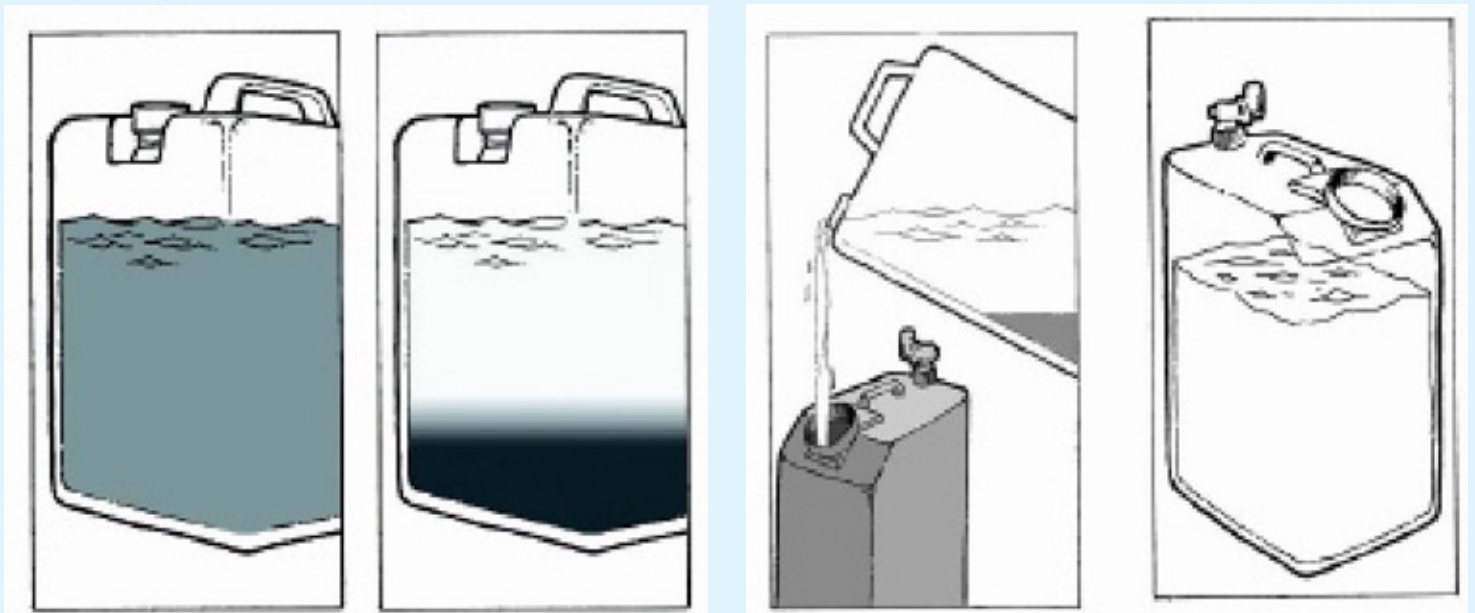
Stages of plain sedimentation using one water container for settling and a second for storage of clear water prior to chemical treatment with chlorine

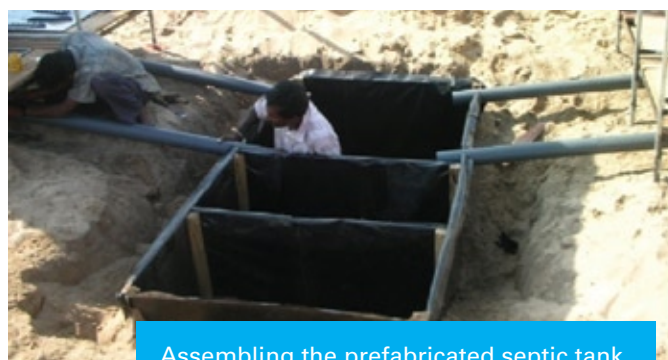
Assembling the prefabricated septic tank

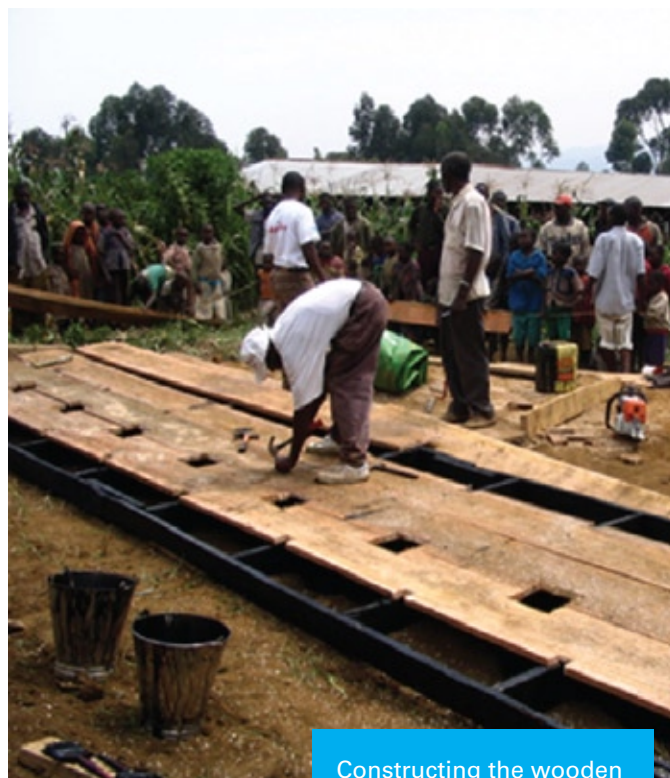
Constructing the wooden floor for a latrine block

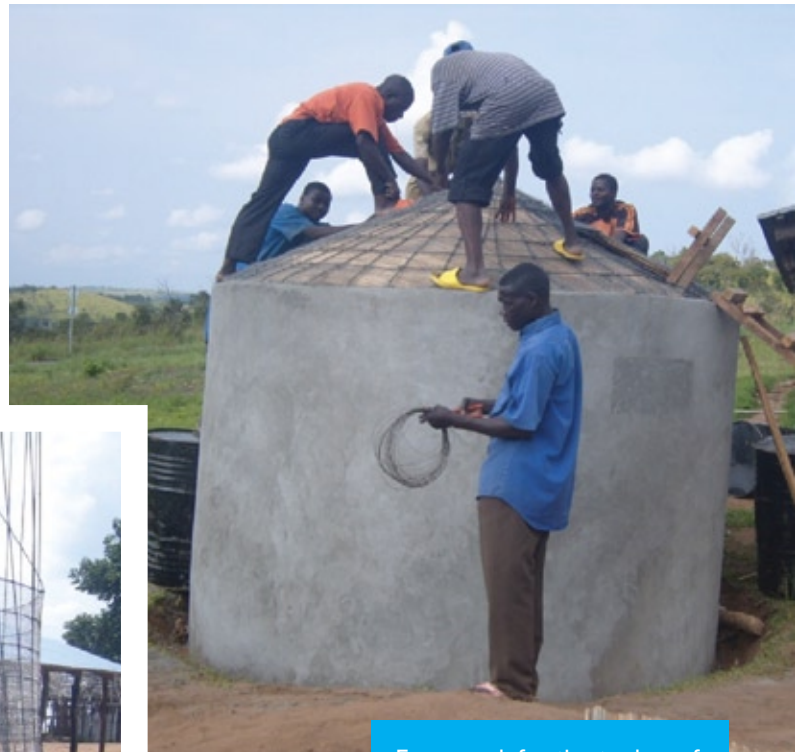
Formwork for the tank roof

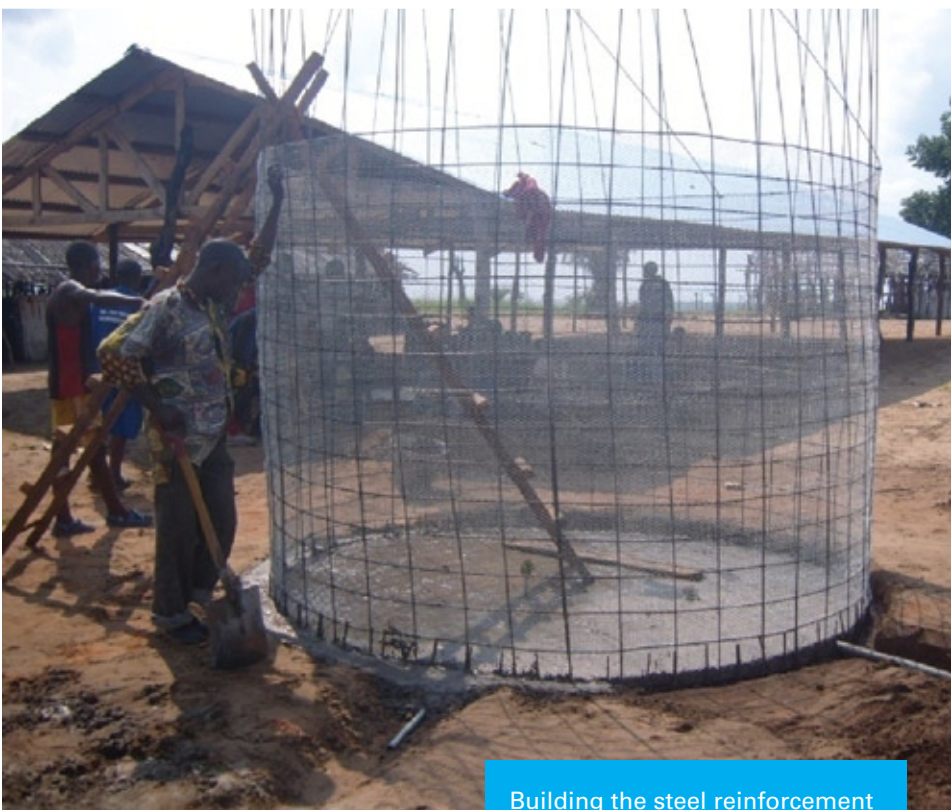
Building the steel reinforcement for a ferrocement tank

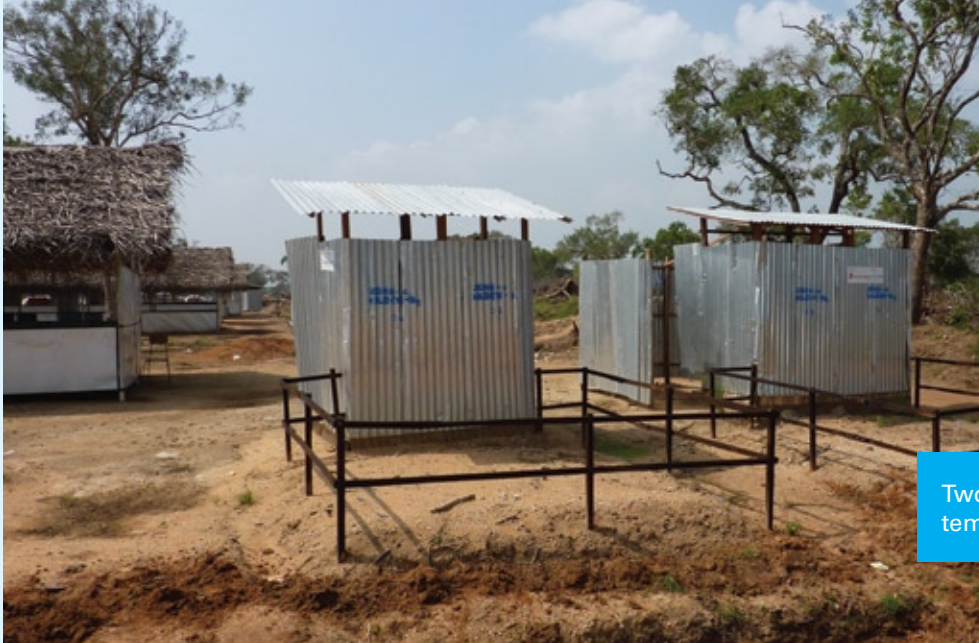
Two twin-pit latrines at a temporary learning space

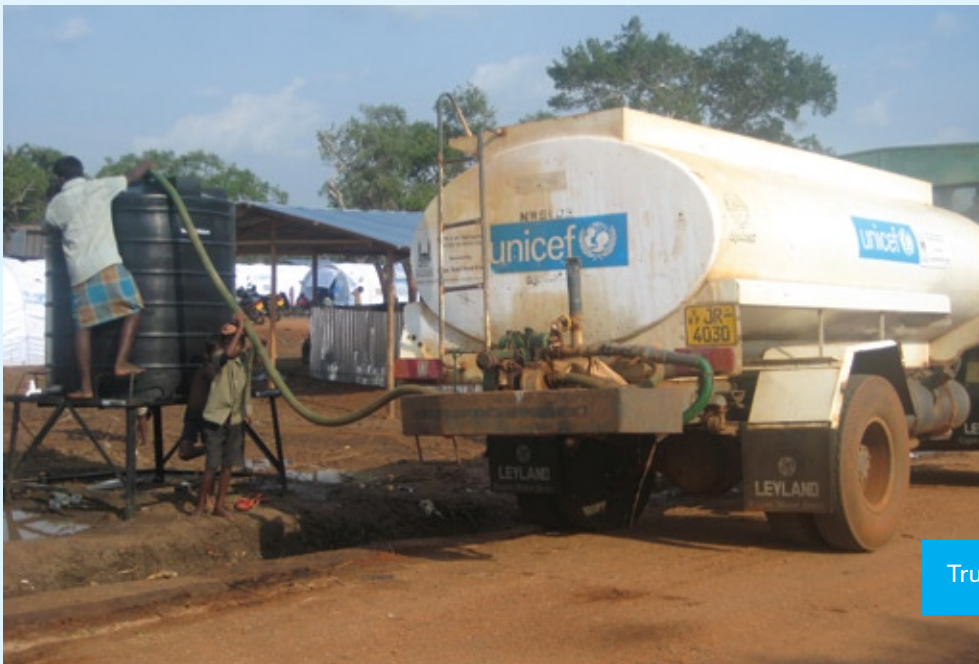
Truck filling a water tank

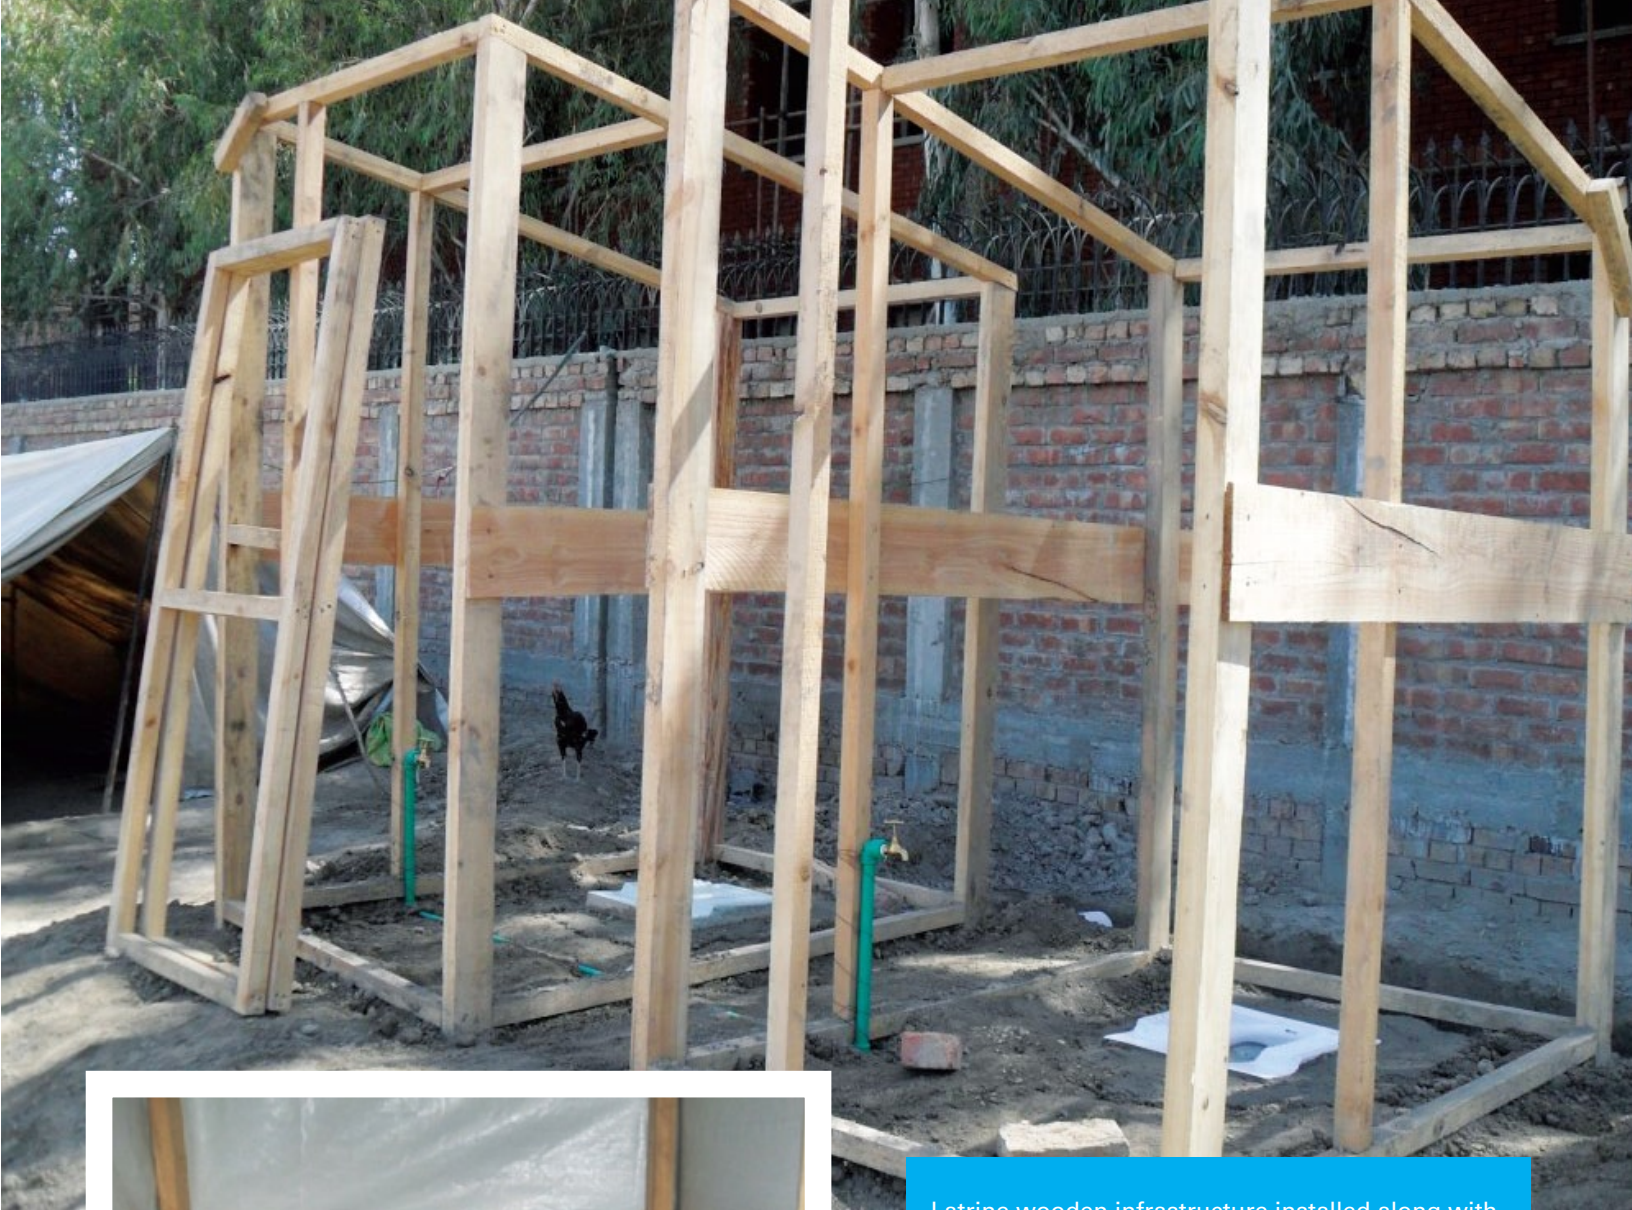
Latrine wooden infrastructure installed along with pour flush pans (above) and completed latrine with plastic sheeting walls (left)

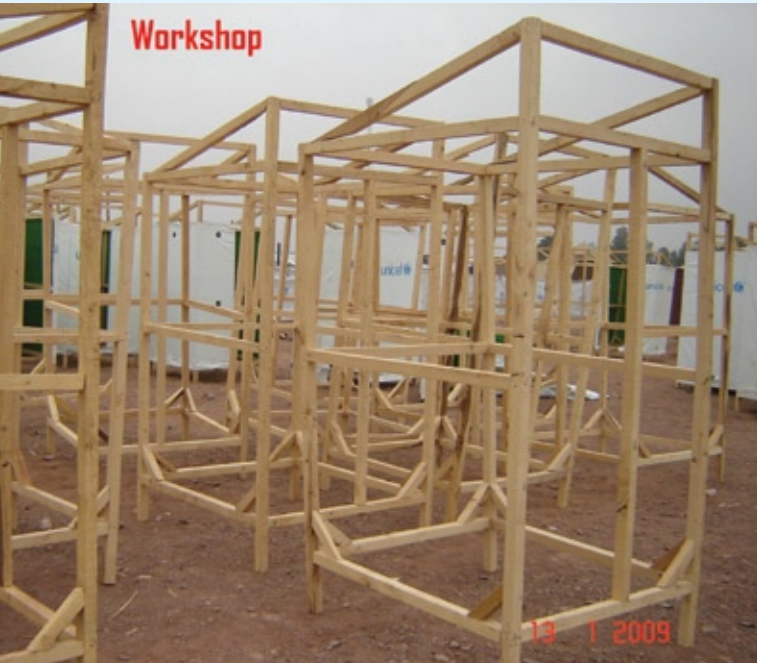
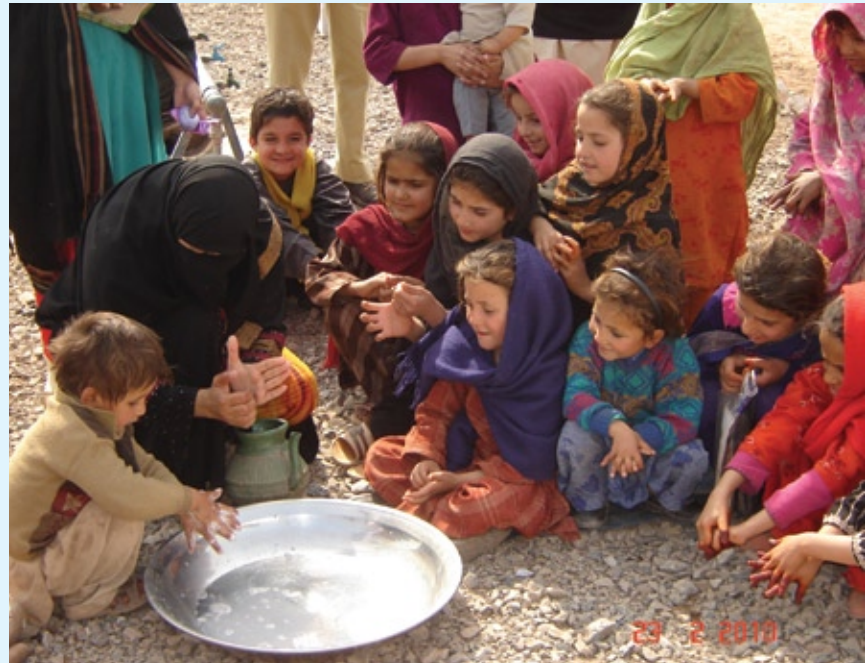
Latrine superstructures are prefabricated in a central yard and moved to the required location when pits are dug (left). At right, a teacher demonstrates hand washing with children in a temporary learning space.

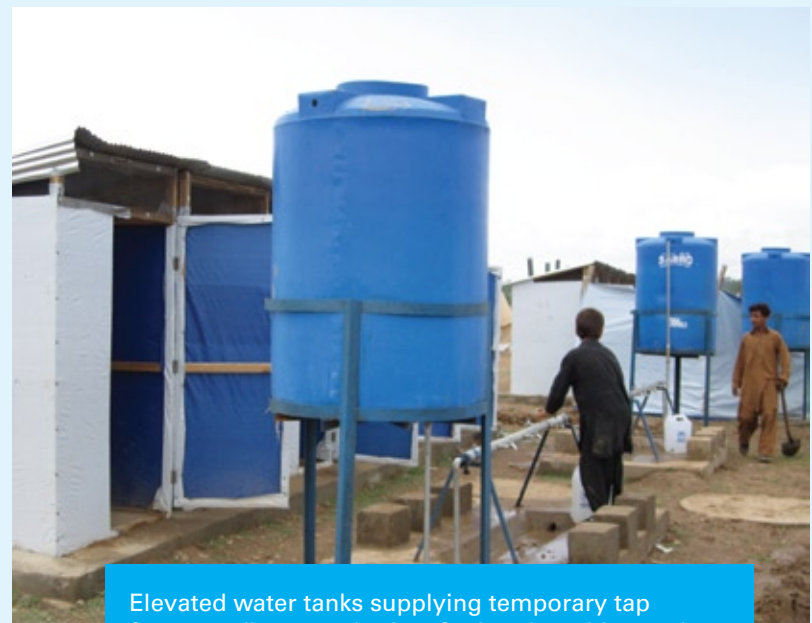
Elevated water tanks supplying temporary tap frames, adjacent to latrine, for hand washing and anal cleansing

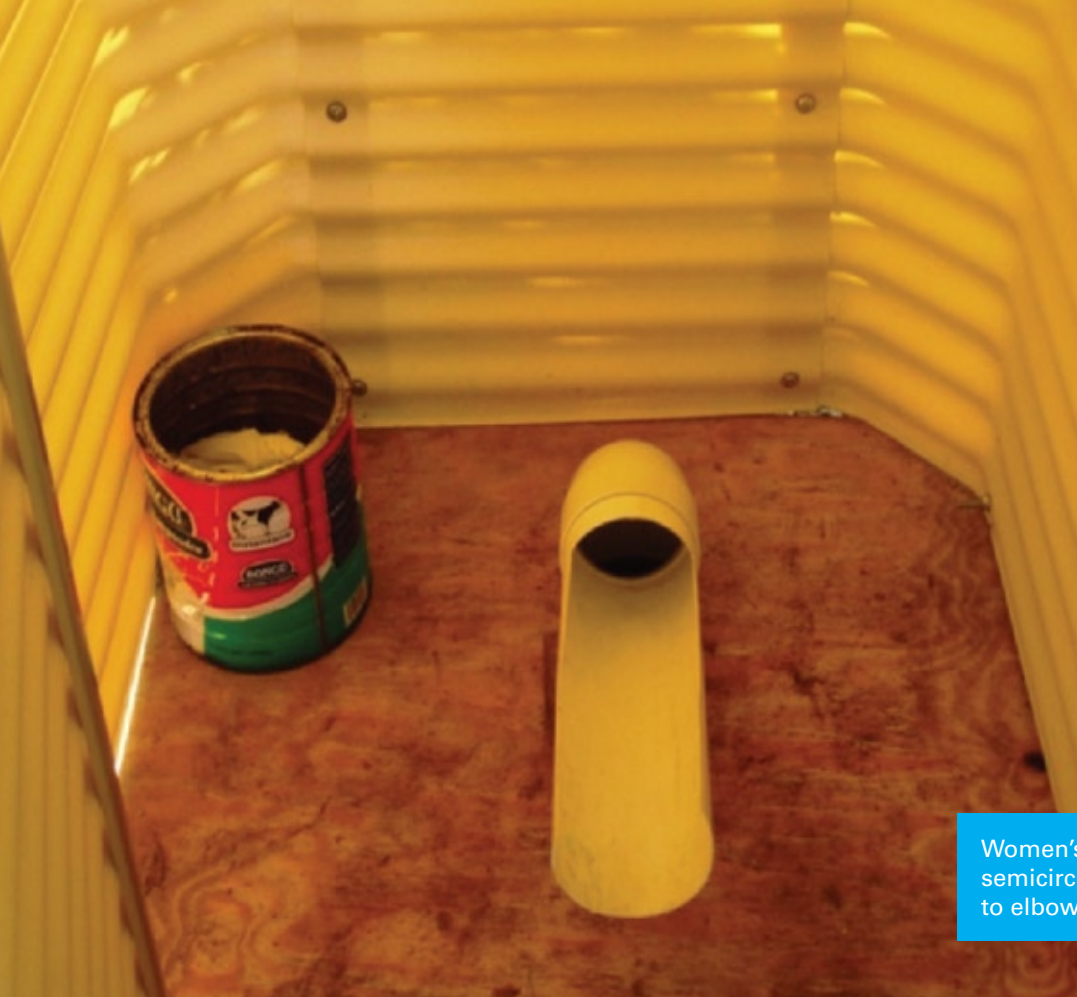
Women's urinal made from semicircle of pipe connected to elbow

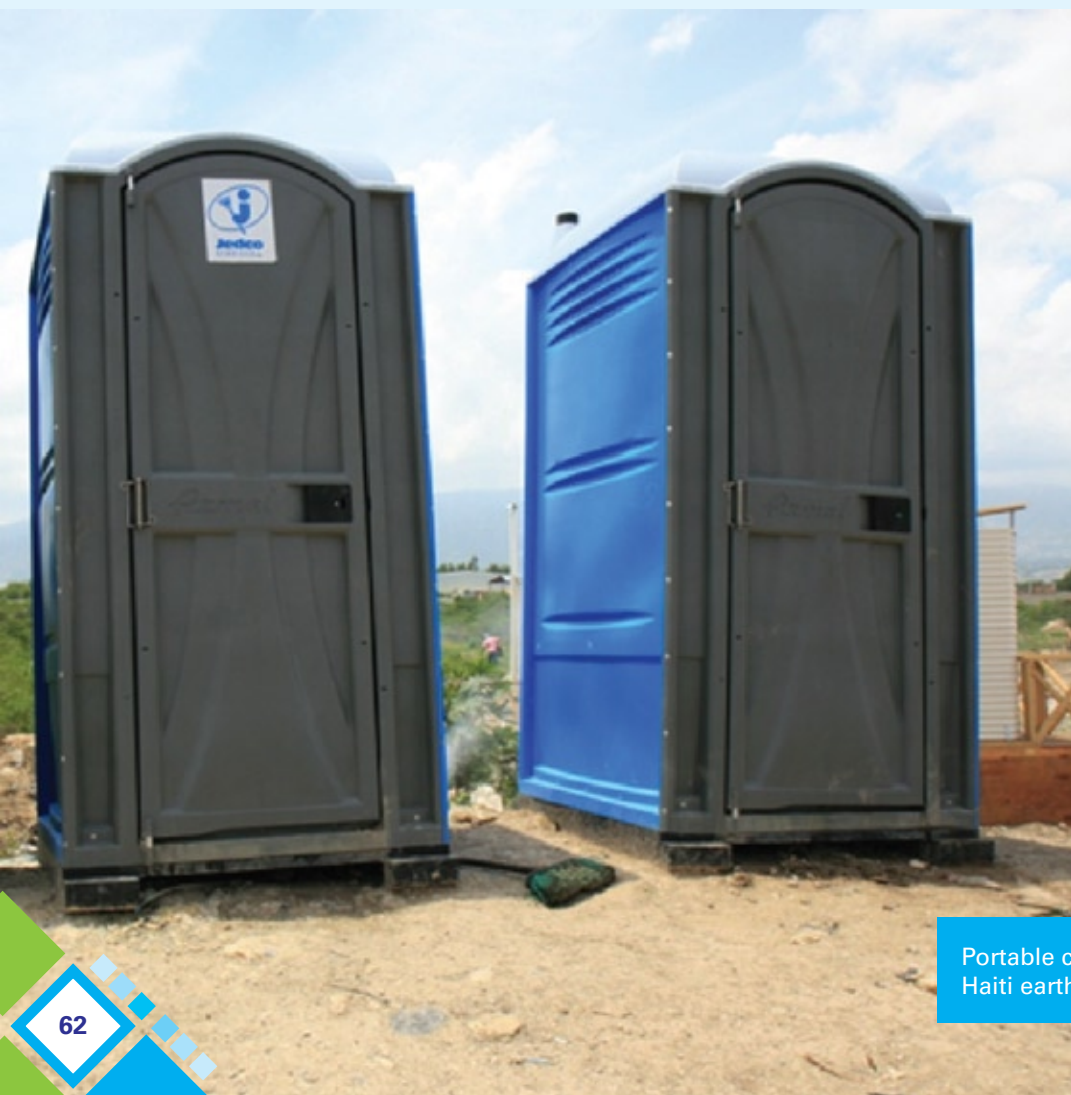
Portable chemical latrines used in Haiti earthquake response, 2010

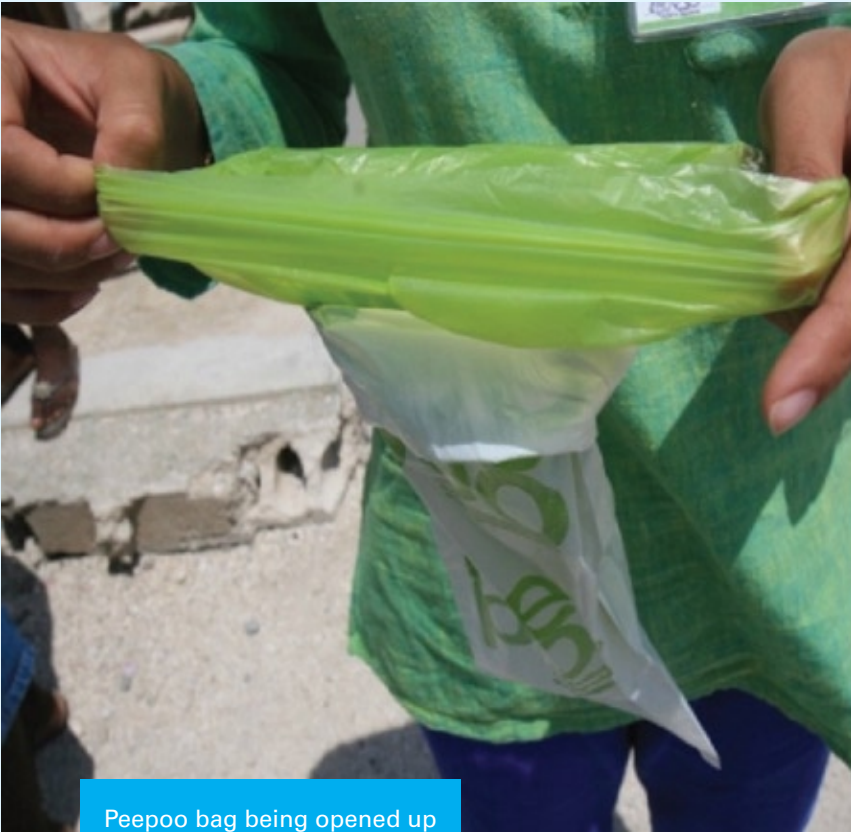
Peepoo bag being opened up

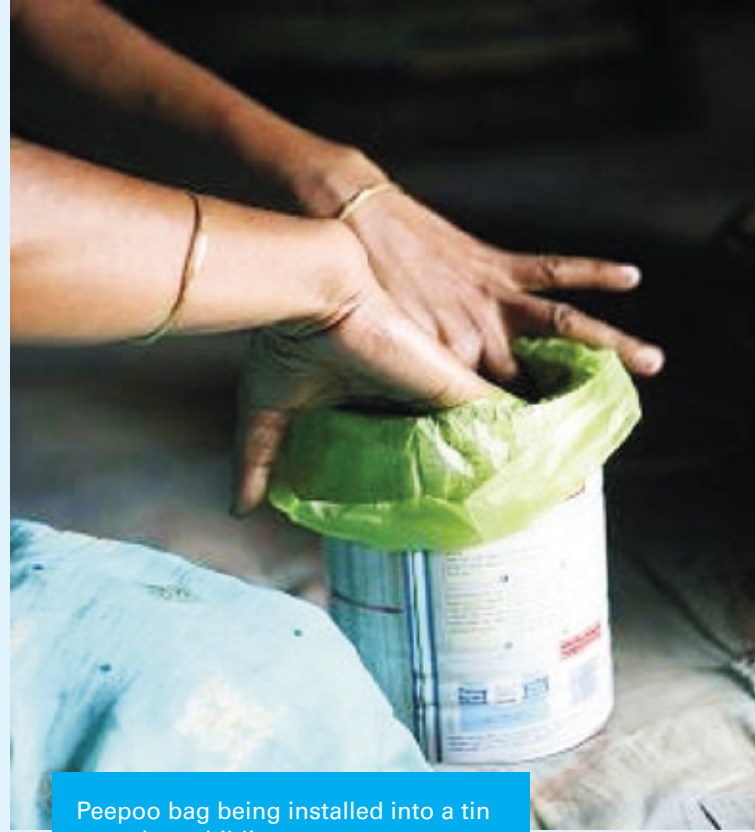
Peepoo bag being installed into a tin to make a child's potty

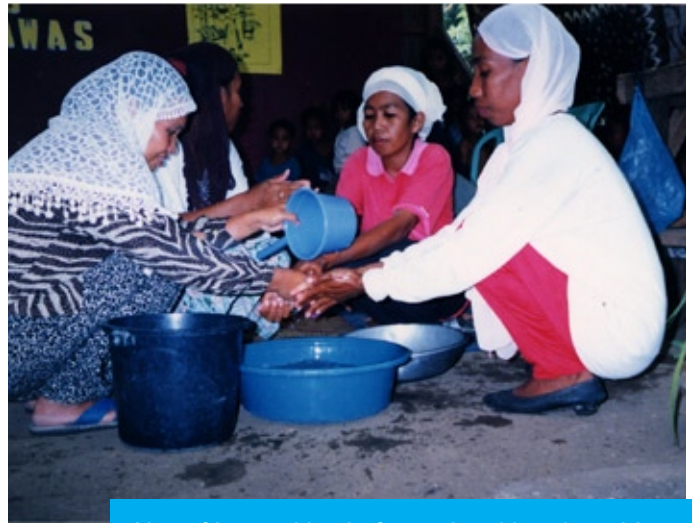
Use of jug and basin for assisted hand washing

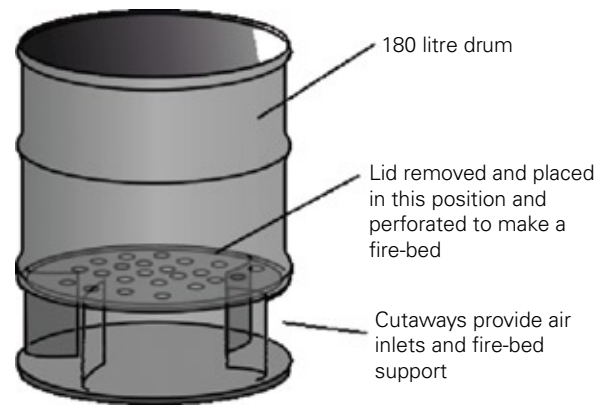
Design for menstrual hygiene management incinerator

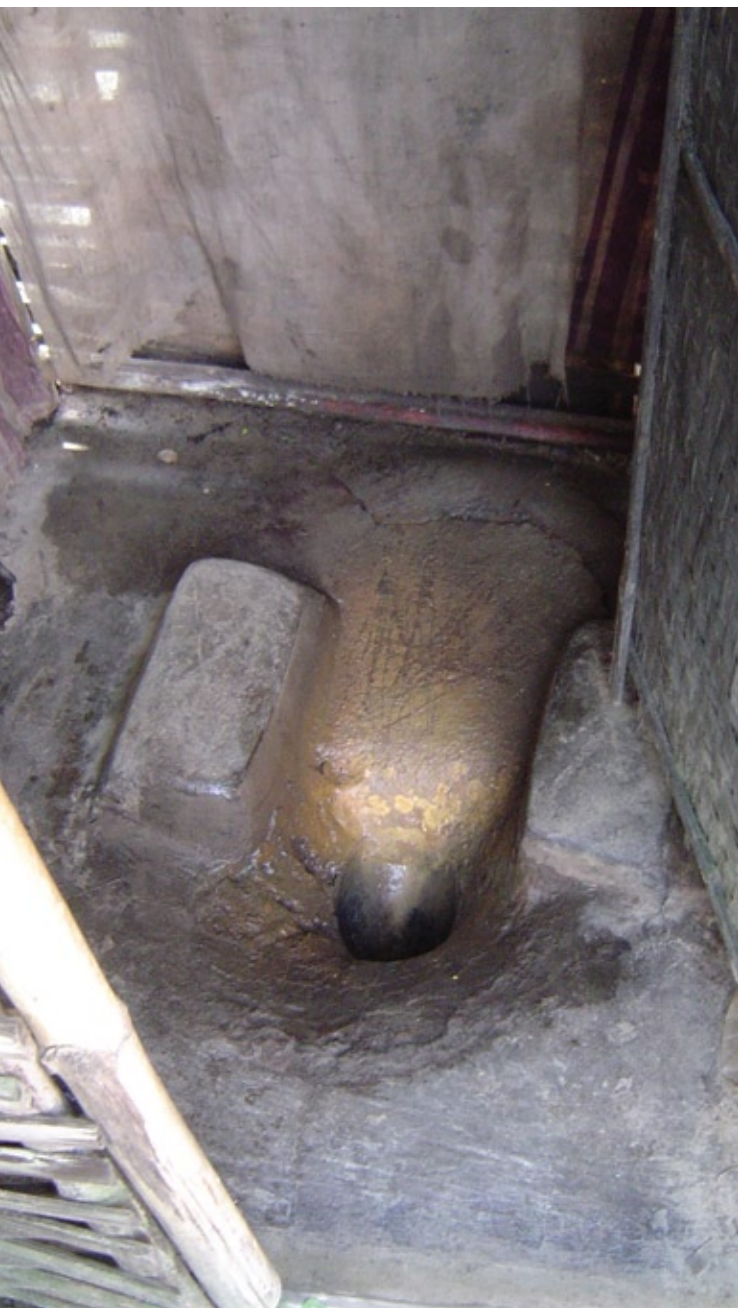
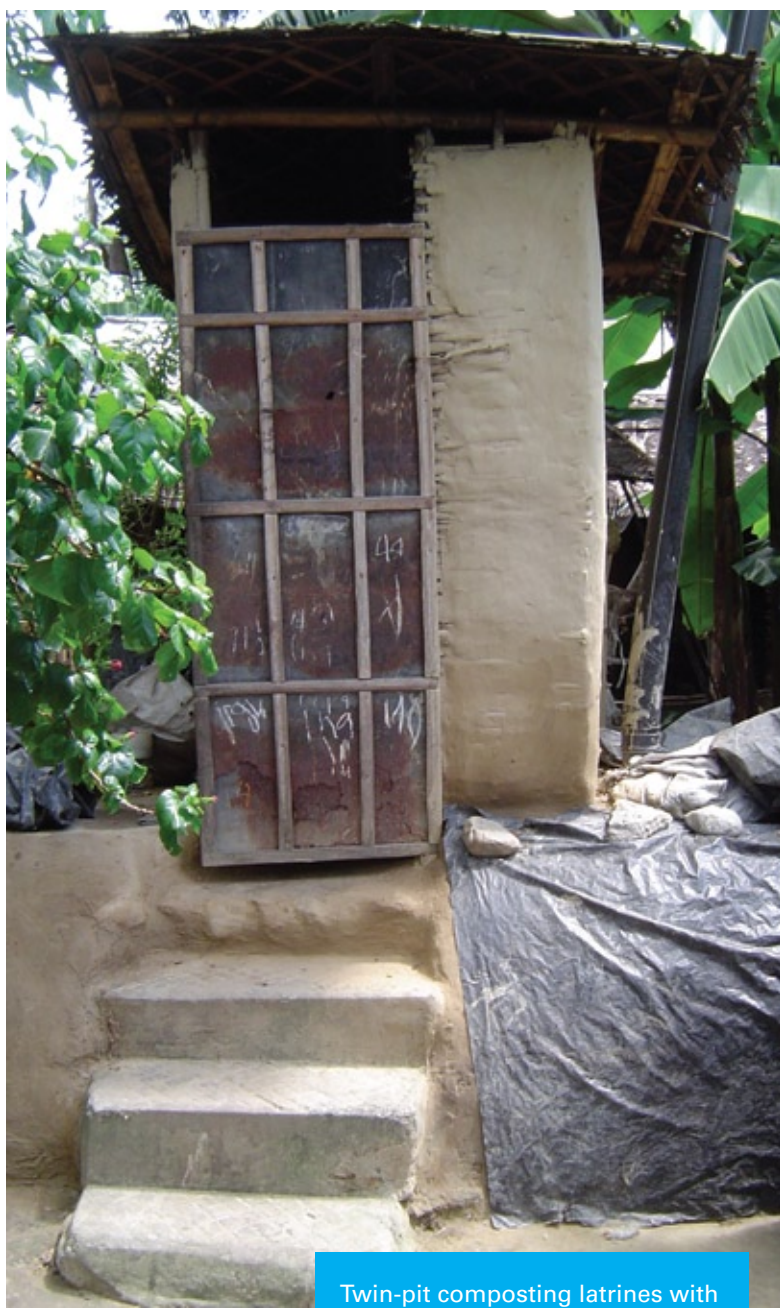
Twin-pit composting latrines with brick and cement pit lining

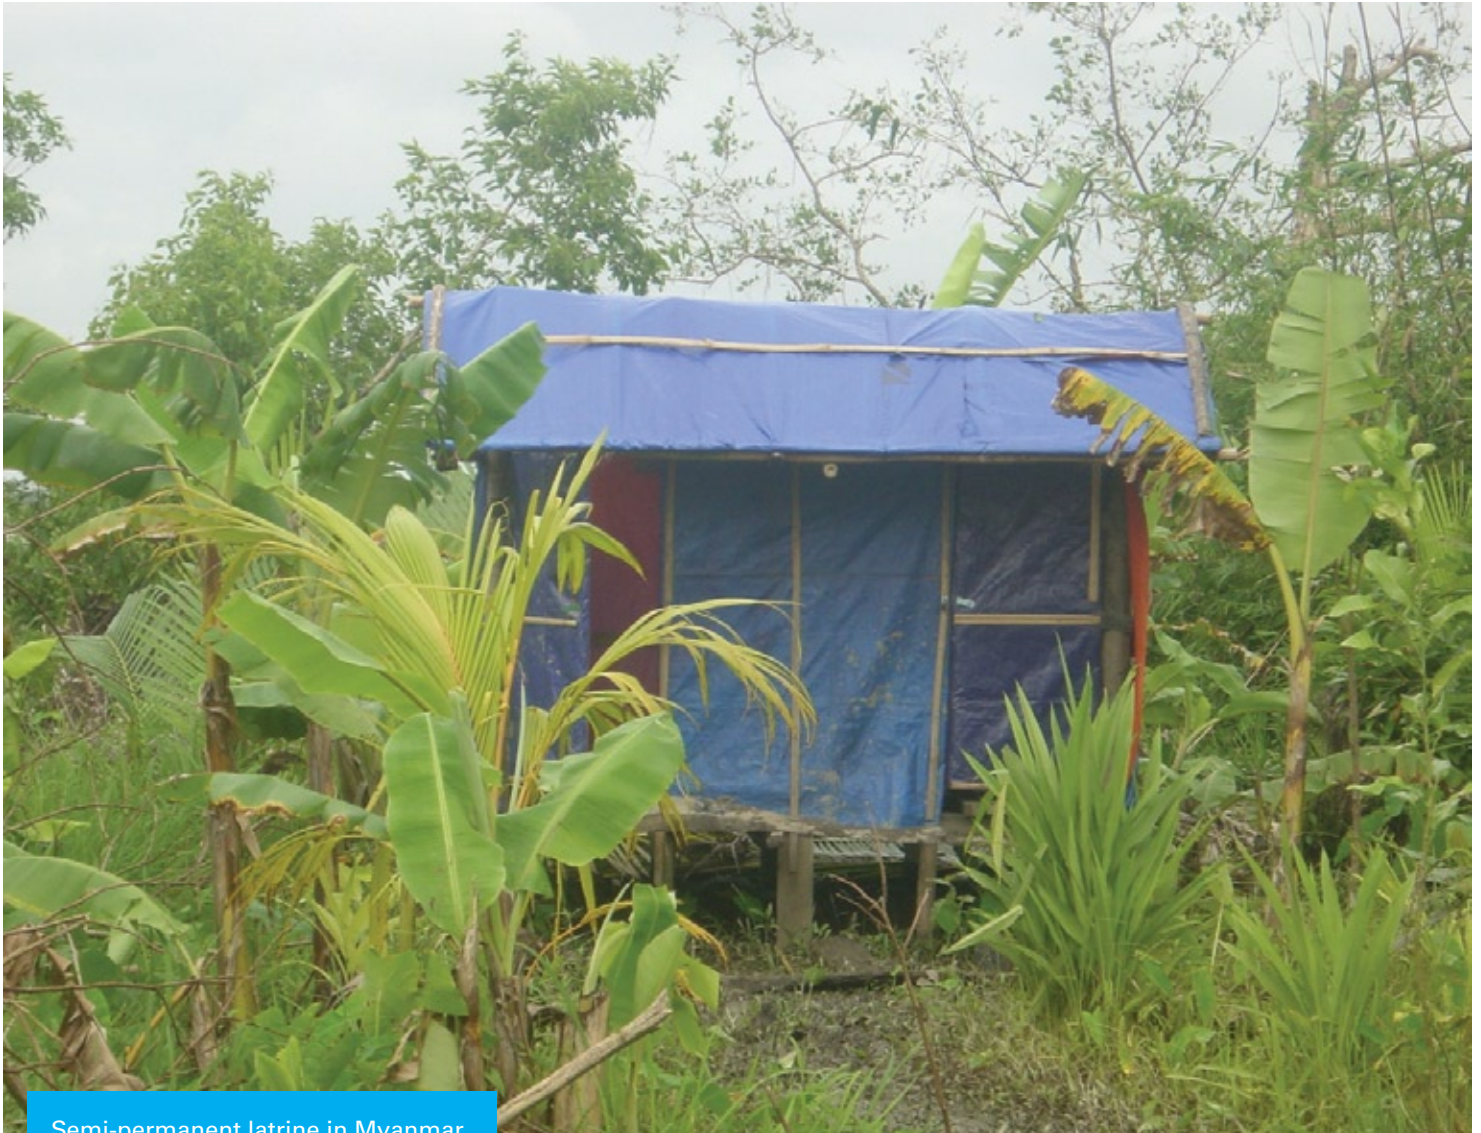
Semi-permanent latrine in Myanmar

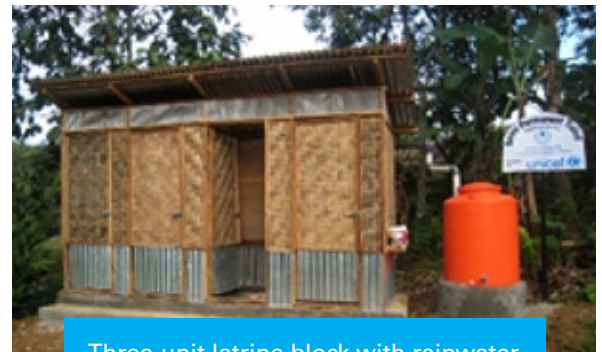
Three-unit latrine block with rainwater harvesting system

Recommended adaptation for future use: The latrine blocks do not provide a privacy screen for girls entering the latrine, which may not be an issue for primary-school-age children, but could affect usage for older girls. The design would most likely need to be adapted for use in secondary schools.

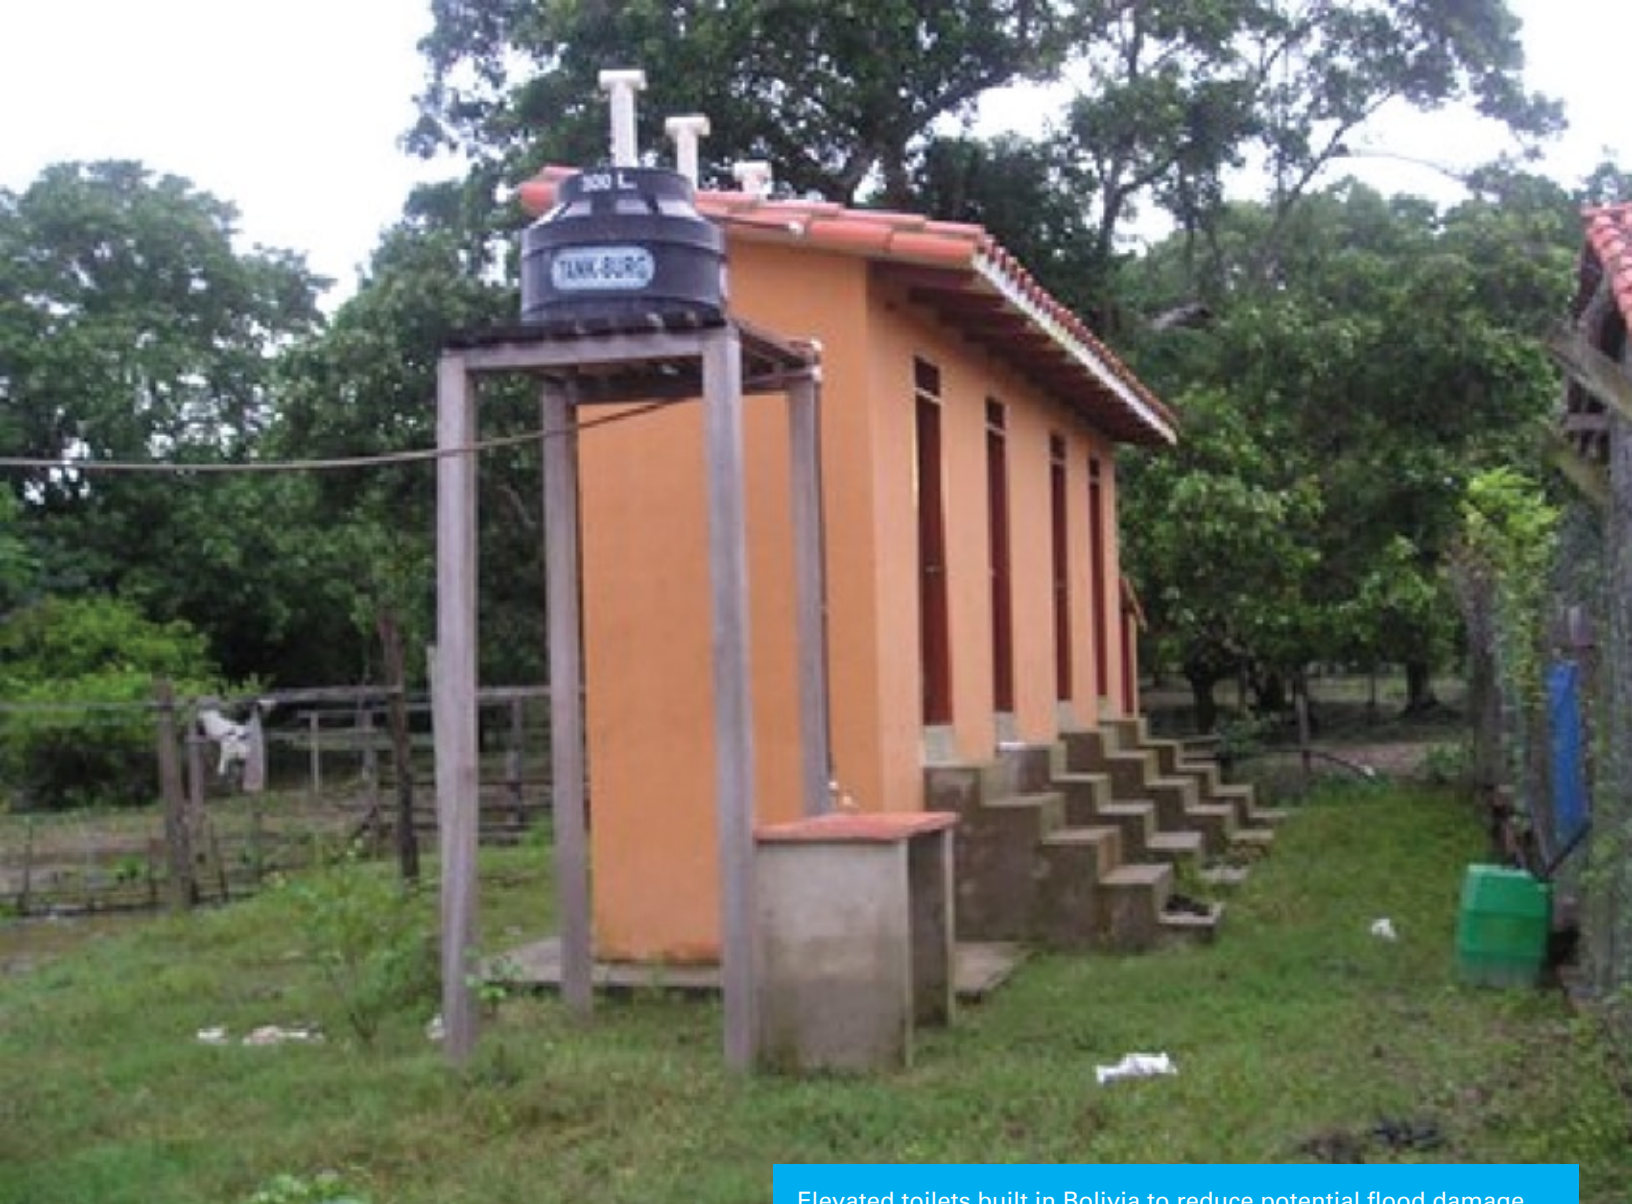
Elevated toilets built in Bolivia to reduce potential flood damage
